EXECUTIVE SUMMARY

The D.M. Fertilizer Company was placed on CERCLIS

A Preremedial site reconnaissance was conducted at 10:35 a.m. on July 23, 1991, by Mr. Gregory A. Spencer of the Illinois Environmental Protection Agency (IEPA). Conditions at the time of the visit were partly sunny skies and a

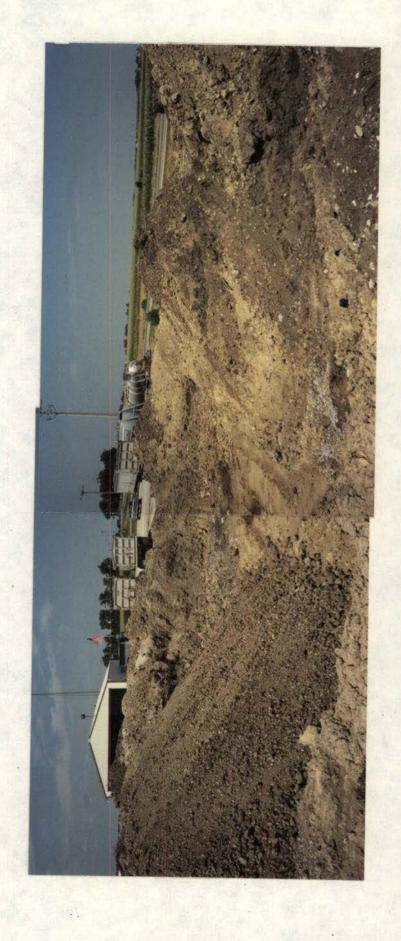
DATE:	1/23/91
TIME:	11:00 a.m.
Photograph	by:
Gı	reg Spencer
Location:	L1833180000
Verm	ilion County
Comments:	Picture taken toward
Picto	re #3 taken toward
South	of contaminated
- Journ	
	pile.
soil	
soil DATE:	pile.
soil DATE:	7/23/91 11:00 a.m.
DATE: TIME: Photograph	7/23/91 11:00 a.m.
DATE: TIME: Photograpi Greg	7/23/91 11:00 a.m.
DATE:	7/23/91 11:00 a.m. n by:
DATE:	7/23/91 11:00 a.m. n by: Spencer L1833180000
DATE:	7/23/91 11:00 a.m. by: Spencer L1833180000

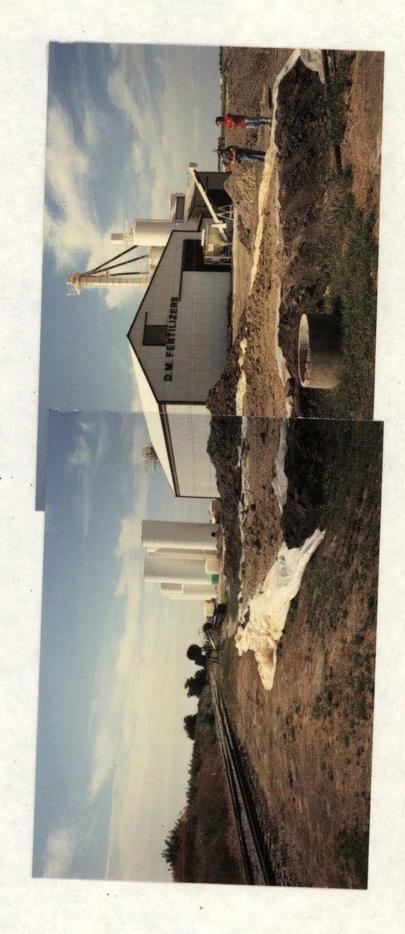
DATE:	7/23/91
TIME:	11:15 a.m.
Photograph	by:
Greg	Spencer
Location:	L1833180000
Verm	ilion County
Comments:	Picture taken toward
Pictu	re #5 taken toward
North	west of new liquid
ferti	llizer area. Also
dry f	ertilizer storage.
DATE:	7/23/91
TIME:	11:15 a.m.
Photograph	by:
Greg	Spencer
Location:	L1833180000
Vermi	lion County
Comments:	Picture taken toward

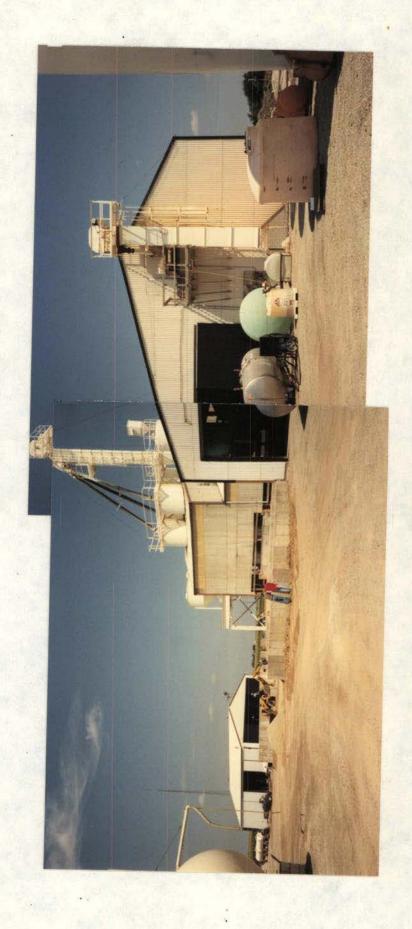
\TE:	7/23/91
TIME:	11:25 a.m.
Photograph	by:
Gre	g Spencer
Location:	L1833180000
Ver	milion County
Comments:	Picture taken toward
Pic	ture #7 taken toward
Sou	theast of plastic
cher	mical tanks. Also
meta	al water tanks in
bacl	kground.
DATE:	
TIME:	
Photograph	by:
Location:	
Comments:	Picture taken toward

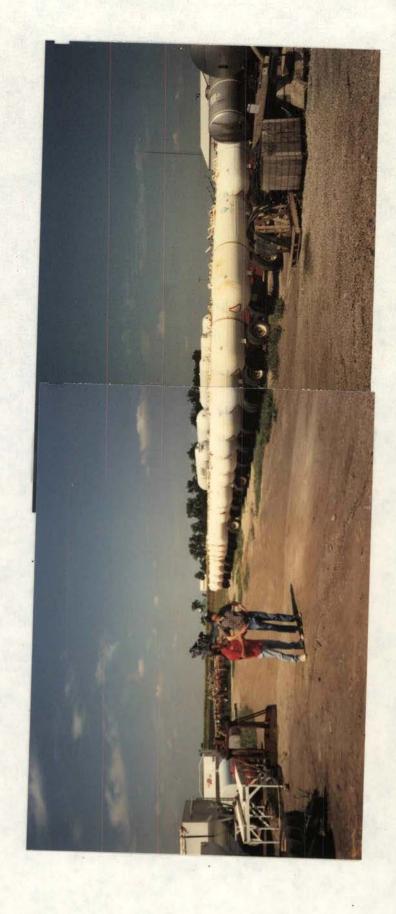
DATE:	1/23/91
TIME:	11:40 a.m.
Photograph	by:
Greg	Spencer
Location:	L1833180000
Vermi!	Lion County
Comments:	Picture taken toward
Pictur	re # 10 taken
toward	Southwest of new
proper	rty acquired by D.M.
Fertil	izer.

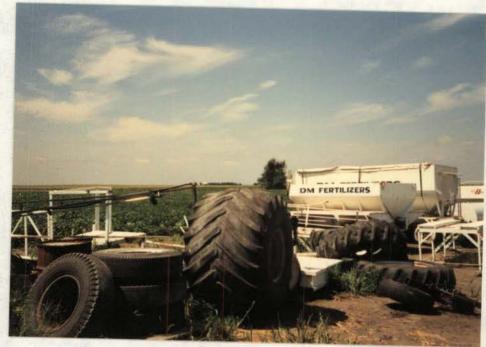
Picture #11 taken toward

East of D.M. Fertilizers

office and shop area.
